HISTORIC PRESERVATION SERVICE TRAINING PROGRAM

URBAN CORPS OF SAN DIEGO

David B. Richardson, M.A., M.F.A.

June 2, 1992

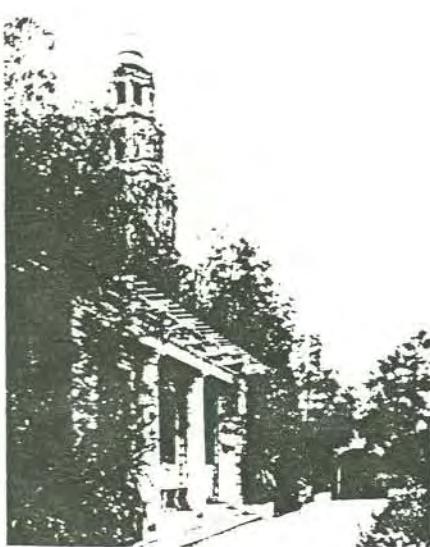
The Alcazar garden pergola as it appeared in 1915.

- Reconstruct the historic pergola on the west side of the garden that existed during the 1915 and 1935 Expositions.
- Remodel the masonry wall on the west side of the garden as shown on the plan to match south wall.
- Renovate the existing south entry arches.
- Remove the existing flood lights from the south entry arches and install pole lights as shown on the plan.
- Widen sidewalks to accommodate concrete benches and light standards.
- Rehabilitate the entry pilasters on the southwest entry.
- Rehabilitate the garden fountains and nearby benches to their 1935 appearance.
- Relocate the maintenance area adjacent to the garden to a new ground maintenance building on the west side of the Alcazar parking lot.

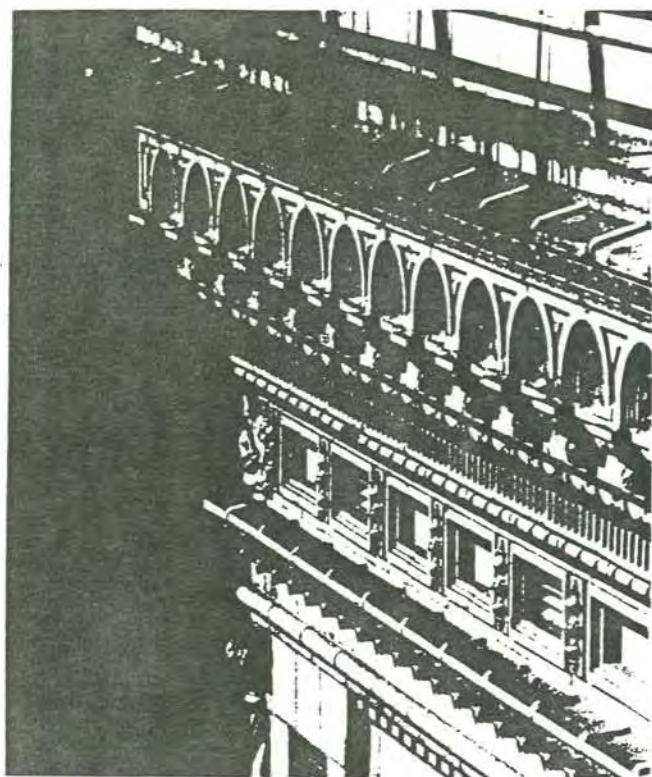
Figure 1. *Terra-Cotta Detailing.* Adaptable to every nuance of color, texture, and modeling, glazed architectural terra-cotta was ideally suited to satisfy the tastes of an eclectic age. Its popularity was, however, short lived; it endured only 30 or 40 years after its introduction as a building material late in the 19th century. (Larry Payne, Houston, Texas)

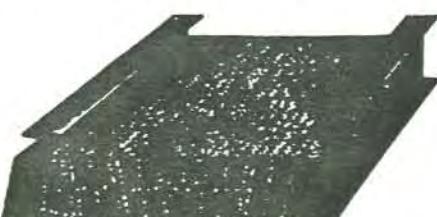
Section Through Typical Arch

Figure 3. *Fireproof construction terra-cotta.* Perspective and section through fireproof construction terra-cotta and I-beam detailing in industrial floor construction. (Detail, "Sweets" Industrial Catalogue of Building Construction, 1906)

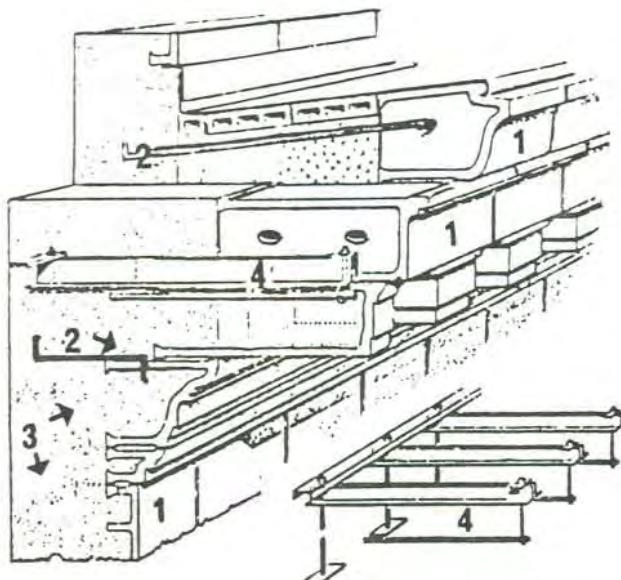
Figure 4. Typical Construction Detail of Glazed Architectural Terra-Cotta Ornament. Construction detailing was often complex. The terra-cotta units (1) which were laid in mortar were fitted with holes or slots to receive the metal anchors (2) (often called "Z" straps or "light iron") which were often fitted directly to the building frame. Masonry backfill (3) (either brick or poured cement) was laid between the terra-cotta units, with the building frame encasing the metal anchor. Overhanging or protruding elements were further secured by metal dowels or outriggers (4). (Detail, Architectural Terra Cotta, Charles E. White, Jr., 1920)

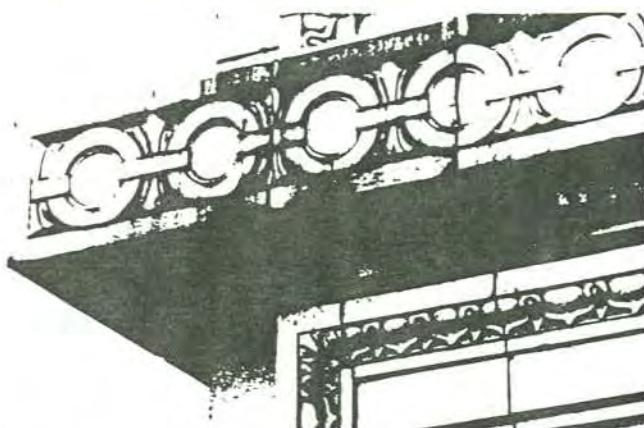
Figure 7. Material Spalling. Excessive expansion of the porous tile body caused by water and freezing temperatures produces major material spalling, a situation often difficult to repair.

Material spalling is a particularly severe situation. Not only is the visual integrity of the detailing impaired, but a large area of the porous underbody, webbing and metal anchoring is exposed to the destructive effects of further water entry and deterioration (Fig. 7). Both glaze and material spalling must be dealt with as soon as possible.

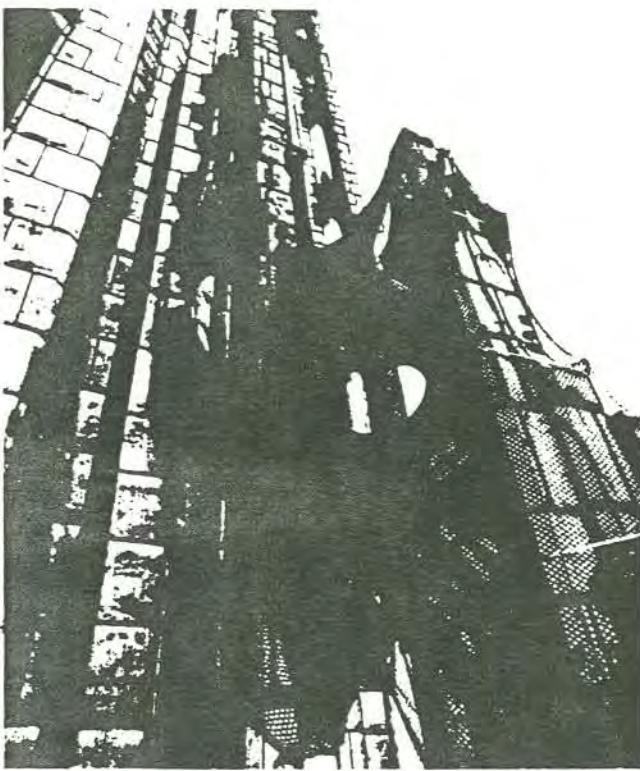
Figure 11. Temporary Stabilization Measures. Falling glazed architectural terra-cotta detailing has become a source of concern, particularly in dense urban areas and locations of high seismic activity. Nylon netting and metal strapping, while not seen as permanent preservation measures, do offer a temporary alternative to the removal of these elements.

Temporary stabilization: Stabilization measures are necessary when deterioration is so severe as to create a situation where pieces of glazed architectural terra-cotta may fall from the building. This is a particular concern with greatly exposed detailing: cornices, balconies, balustrades, urns, columns, buttresses, etc. Restoration work on these pieces is expensive and often must be carried on over a period of time. Unstable terra-cotta pieces are often removed or destroyed in lieu of such measures. This is particularly true in areas of heavy traffic-related vibrations or in earthquake zones. There are, however, less severe measures which may be employed on a temporary basis. Substantial success has been achieved in securing unstable glazed architectural terra-cotta pieces with metal strapping and nylon net (Fig. 11). While these measures should not be seen as permanent preservation solutions, they do offer temporary alternatives to the wanton destruction of significant glazed architectural terra-cotta detailing in the name of public safety and local code compliance.
